**DEPARTMENT OF TRANSPORTATION****DIVISION OF ENGINEERING SERVICES**

Contract #: 04-0120F4Cty: SF/ALA Rte: 80 PM: 13.2/13.9File #: 69.28**WELDING INSPECTION REPORT****Resident Engineer:**Pursell, Gary**Address:** 333 Burma Road**City:** Oakland, CA 94607**Report No:** WIR-000076**Date Inspected:** 02-Mar-2007**Project Name:** SAS Superstructure**OSM Arrival Time:** 900**Prime Contractor:** American Bridge/Fluor Enterprises, a JV**OSM Departure Time:** 1730**Contractor:** Zhenhua Port Machinery Company, Ltd (ZPMC), Changxing Island **Location:** Shanghai, China

**Bridge No:** 34-0006**Summary of Items Observed:**

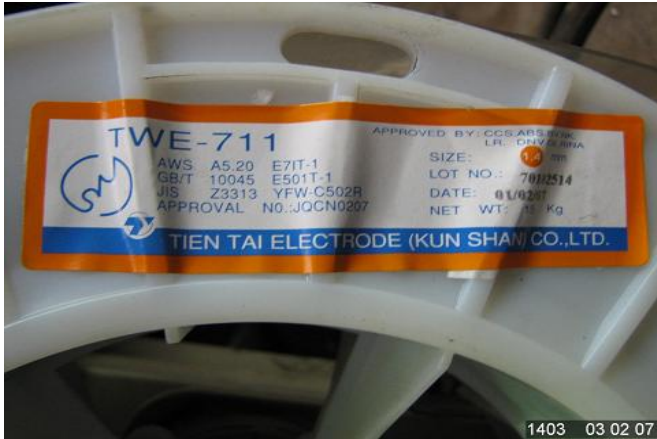
ZPMC, welder operator Jiang Xian Hu was observed by the QA Inspector performing welding operations following the preliminary welding procedure specification PWPS-B-T-2233-F-1 for the PQR identified as HP200709. Base metal was designated as A-709-50F-2 (Heat # 07200455030101) and met the fracture critical requirements. The root opening of the joint was approximately 6 mm. ZPMC followed the production procedure welding procedure specification (WPS) criteria (AWS 5.13) using the automatic flux cored arc welding gas (FCAW-G) process in the vertical (3G) position with the 1.4 mm diameter TWE-711 electrode. The QA Inspector verified dimensions for the test coupon, amperages, voltages, travel speeds, preheat and heat interpass temperatures. The QA inspector recorded welding parameters for a total of 9 passes (6 layers). The QA inspectors discovered that the welding parameters taken by Quality Control (QC) inspector Cheng Libin and ZPMC QA inspector Xu Jun appeared to be accurate and in accordance with the contract documents with the exception of the travel speed. The QA inspector had a conversation with the Mr. Xu and Deputy General Manager Hu Gang. The QA inspector brought to the attention of Mr. Xu and Mr. Hu that the travel speed recorded by Mr. Xu was 110 mm/min in lieu of 123 mm/min. Mr. Xu agreed. Mr. Xu relayed to the QA inspector that the travel speed was inadvertently recorded as 110 mm/min. Mr. Hu relayed that ZPMC was going to revise the PWPS-B-T-2233-F-1. ZPMC revised the travel speed and heat input listed on ZPMC preliminary WPS and proceed welding until completion. ZPMC QC Jiang Xiao Hu witnessed the testing and performed visual weld inspections. The QA inspector issued a lot number of B71-001-07 after the completion of the PQR. See TL\_6032 for details of this test. The digital photograph below shows the PQR HP200709 electrode description.
